ZF 6HP Transmissions - Mechatronic Sealing Sleeve Seepage

NEW E53, E60, E61, E63, E64, E65, E66, E85, E90, E91, E92, and E93 vehicles with ZF 6-speed 6HP19/21 or 6HP26/28 transmissions produced up to 04/08

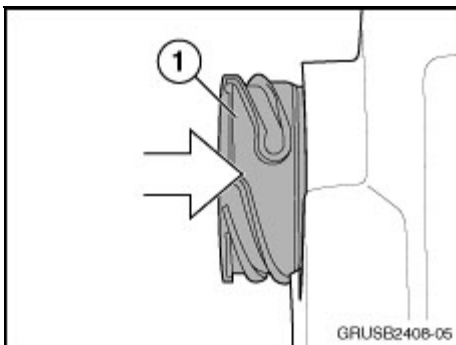
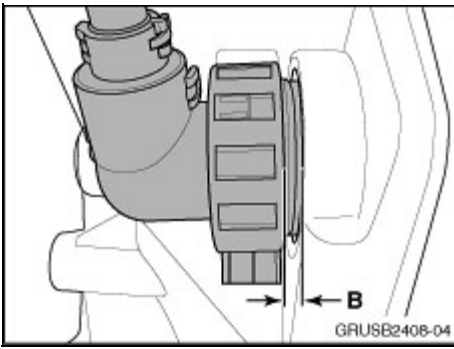
3. After installation, the correct distance between the transmission harness connector and the housing surface (B) should not exceed 3 mm.

When installing the transmission harness connector, do not use excessive force - locking of the connector should not require an increased effort. This would be

an indication of an incorrectly installed sealing sleeve!!!

Make sure to push the sealing sleeve firmly into the housing assembly before closing the white locking tab of the Mechatronic.

To ease the sleeve installation, use some lubrication (e.g., transmission fluid) on both sleeves' O-rings.

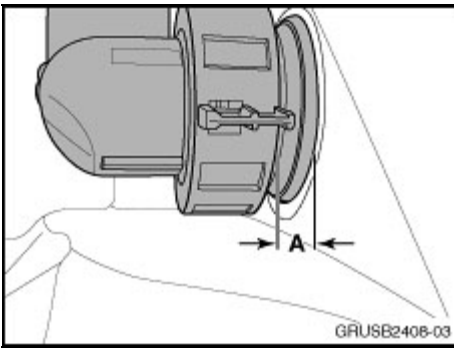
NEW 4. If the distance between the connector and the transmission housing (A) measures approximately 7 to 8 mm, the sealing sleeve was installed incorrectly. In such a case, an intermittent connection problem between Mechatronic and the vehicle harness connector will occur, resulting in various EGS communication faults (e.g., FC 5079 "Serial wire message missing"; FC 507A "Serial line signal plausibility"; "Gearbox Emergency Program" lamp illumination; and the transmission entering a failsafe mode).

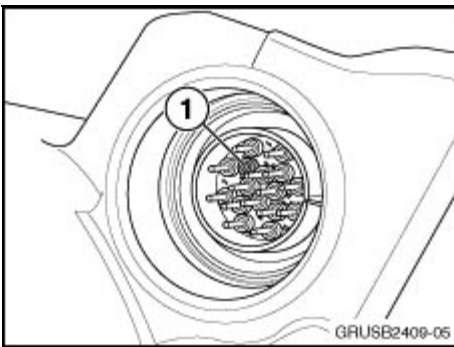
5. In some cases, the incorrectly installed sealing sleeve may permanently damage pins in the Mechatronic connector (X8500). In such a case, the Mechatronic module has to be replaced (**pin repair is not possible**).

The illustration shows an example of a broken and missing pin #4 in the X8500, caused by improper sleeve installation; this resulted in the customer's complaint about the inoperative Sport Mode of the transmission.
