**SUBJECT****Fuel Injector Faults****MODEL**

E70 with the M57Y produced to May 2012

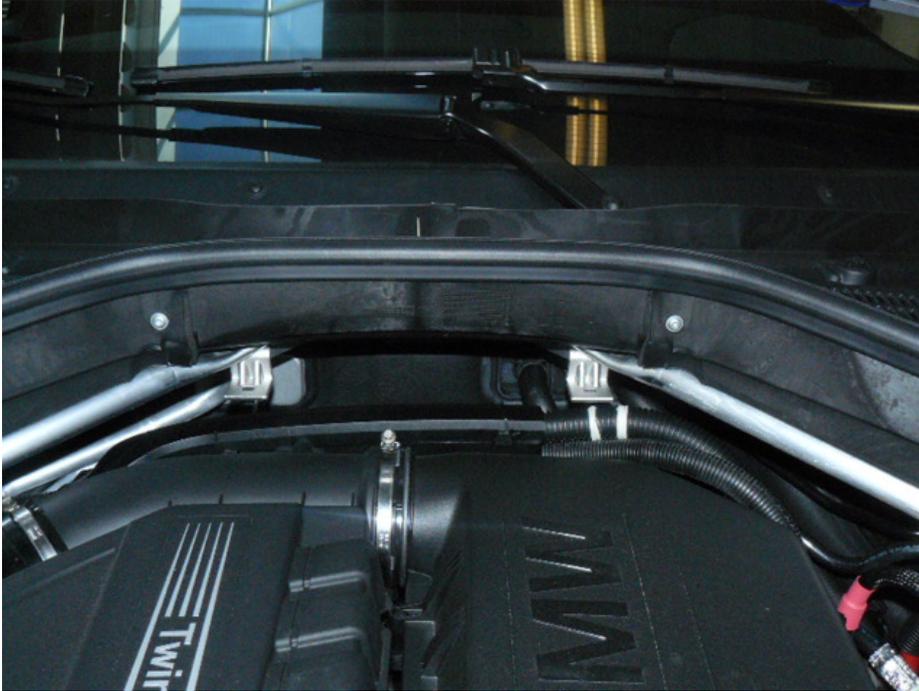
Seal the top center of the engine compartment partition wall:

Required preliminary work:
Remove the hood seal and the left and right microfilter housing covers.
