Service Action: Replace Charge Air Temperature Sensor (M57Y)

E70 with the M57Y diesel engine produced from 1/22/2008 to 4/31/2011

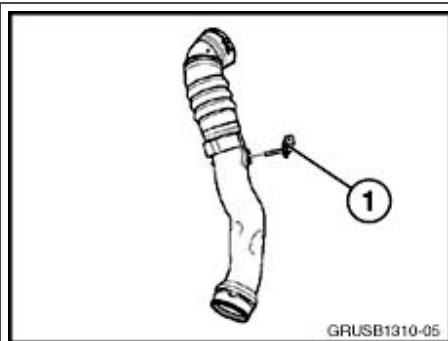
The Service Engine Soon lamp (MIL) is illuminated. Fault Code 4C52, "Charging air temperature sensor, plausibility" is stored.

The charge air temperature sensor has failed.

Replace the charge air temperature sensor (1) (refer to Repair Instruction RA 13 62 538).
