Service Action: Replace the SCR Active Tank (M57Y)

E70 with the M57Y diesel engine produced from 1/2008 to 8/2009

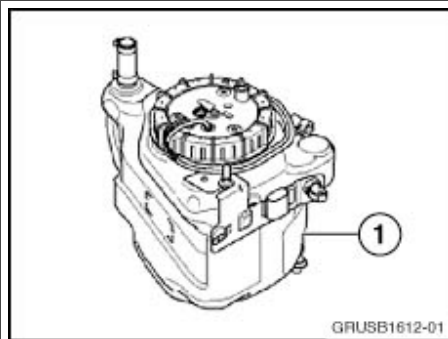
The temperature sensor in the Selective Catalyst Reduction (SCR) active tank may fail. A more robust sensor has been developed. This sensor is integrated into the active tank.

Replace the SCR active tank (1) (refer to Repair Instruction RA 16 19 020). Fill the new tank with new diesel exhaust fluid (DEF)
Note: The E70 Diesel engine Active Tank capacity is 6.4 liters or 1.70 gallons.
