DIY Pulling and troubleshooting the ZF 6HP26 Mechatronics Unit E-shift Unit

pulled from various sources by Wilson009

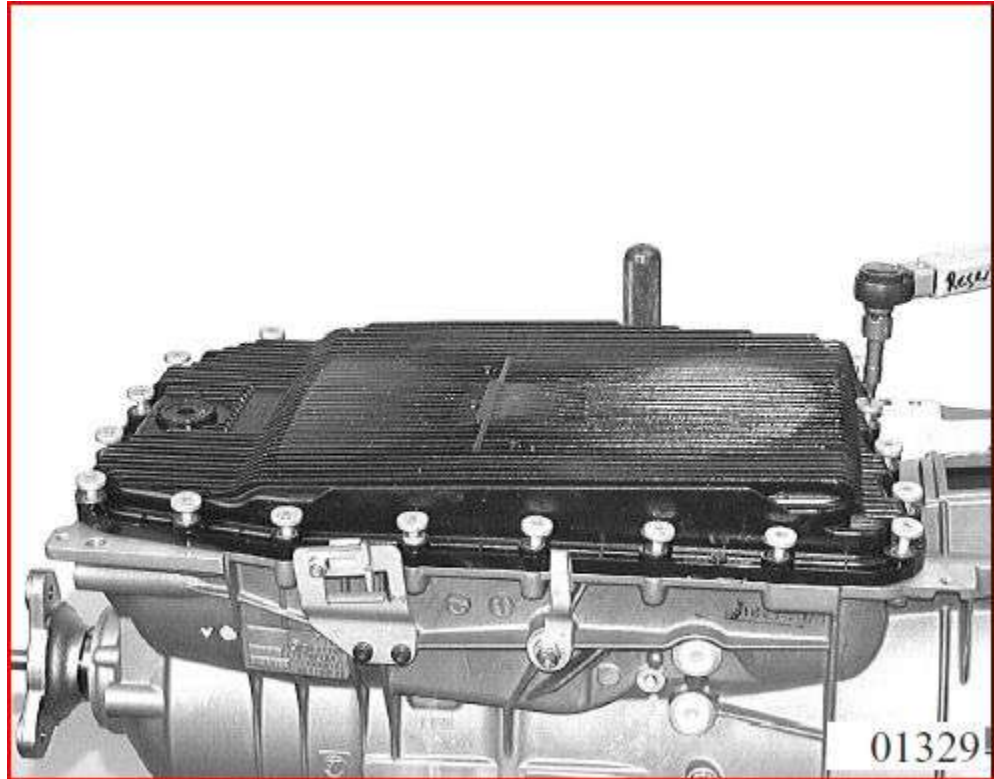
- - Recommended Order New Pan Bolts from the dealer the for some years. Out bolts torx size is too small and they strip easy as a result. The new bolts take a larger torx bit.
 - The following parts should be replaced regardless of whether they are broken or not. Do it while you have it accessible
 - 4 sealing sleeves
 - 1 Bridge seal adapter
 - Mechatronics Sealing Sleeve
 - Absorbent material (cat litter at the autostore) This is a very messy job and you will spill oil everywhere including your hands and maybe your head at some point.
-
1. Drain your oil and dispose or reuse if you just replaced it recently if you want
 - a. Make sure you can open your Fill plug before draining
 2. Unbolt your transmission Pan. If you strip the torx bolt use channel locks.

- a. Recommend replacing your bolts

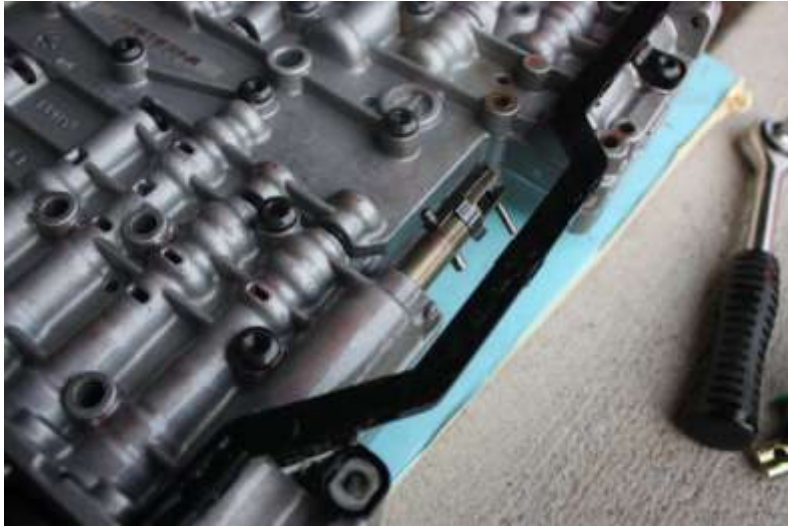
Figure 1 pic of Park Cylinder

7. This is where I found my parking lock error. MV2 which is responsible for that and an open circuit or a reading of 1. I ordered a replacement from ZF distributor Errickson Industries for \$60 bucks. Excellent company very friendly. Contact is Nat www.erikssonindustries.com 800-388-4418 in CT. Had my package in 2 days. This fixed my Parking Lock errors.

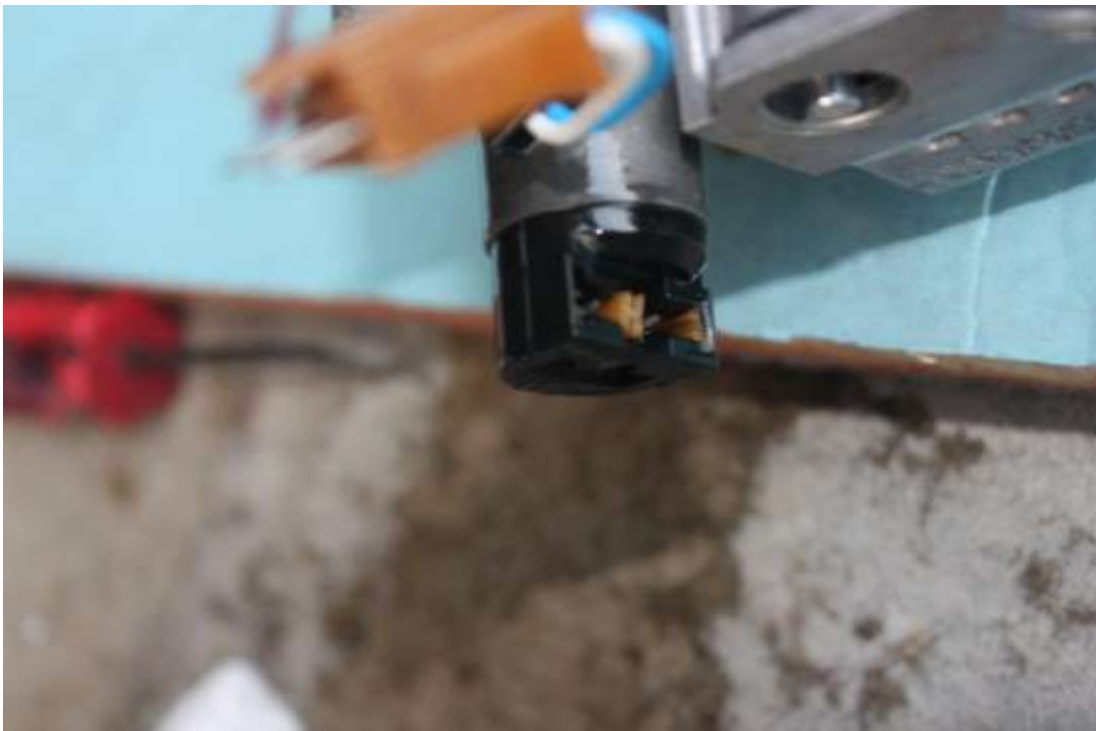
Figure 2 Bad Solenoid also broke off plastic in there from harness. I think i did it while inspecting it.

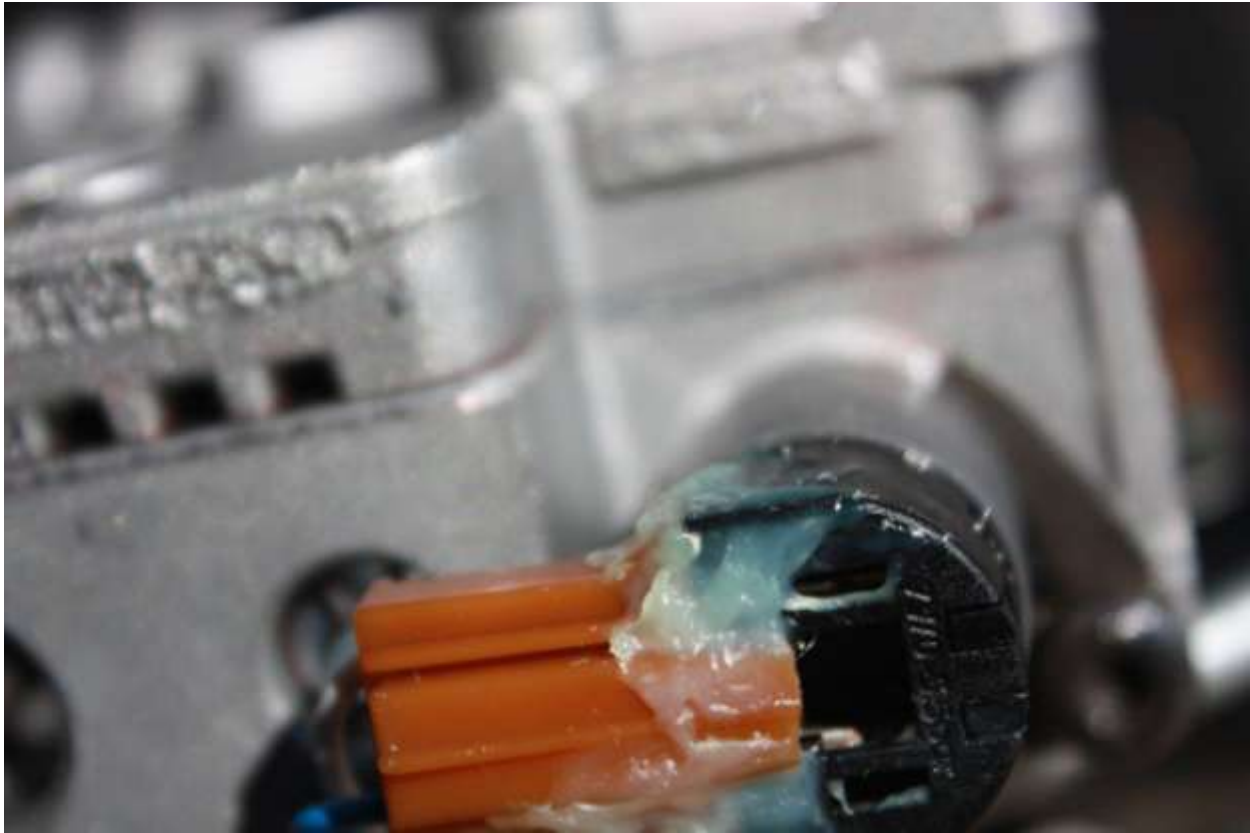
Figure 3 New Solenoid with Harness glued in tight.

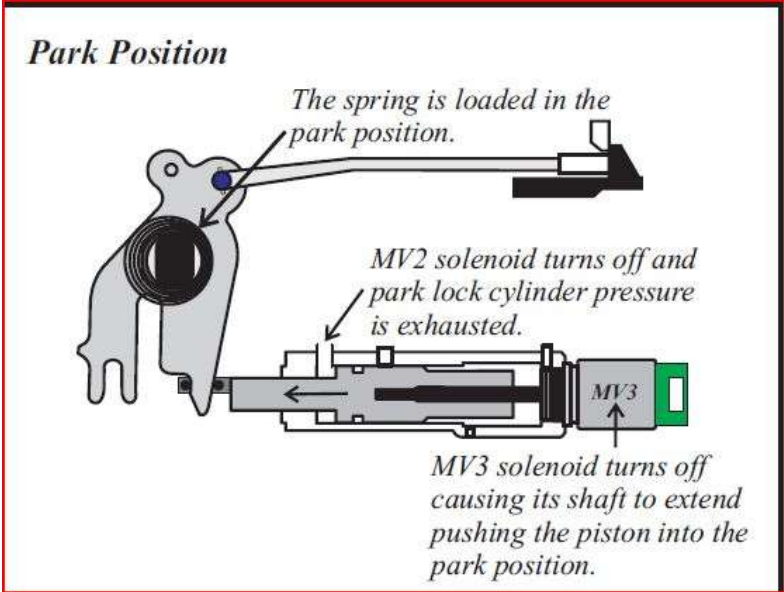
Figure 4 Shows MV2 Function which malfunctioned on my car

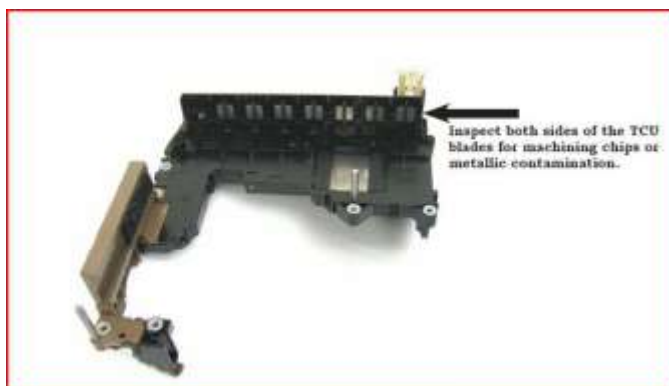
Figure 10 Spray and Clean and inspect for Cracks. This unit can also be opened

10. Remove the bolts that hold the valve body and the TCM together and carefully slide them apart. Any metal coating on these can mess up reading as well as impede contacts and signals. Now Clean the valve body and TCM. I used Paper Towels and Brake Cleaner and Qtips.

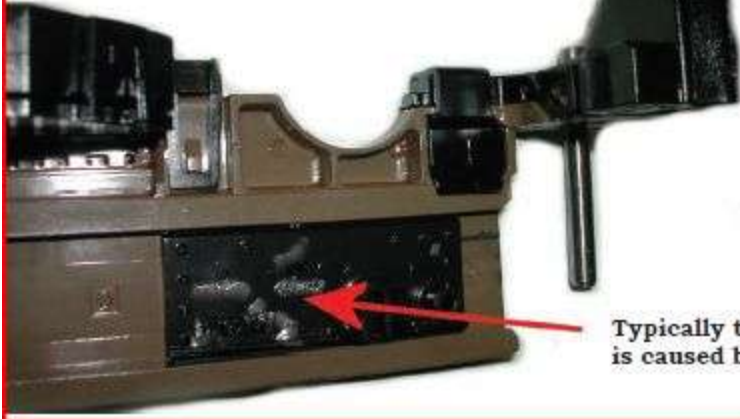
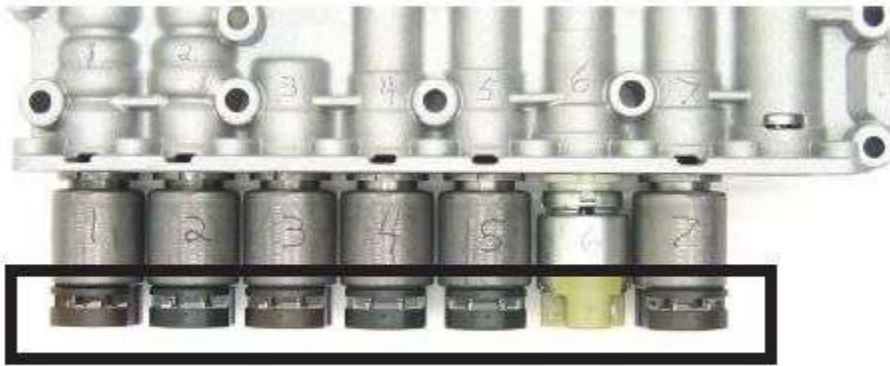
Typically the contamination is caused by clutch debris.

NOTE: Inspect the terminals thoroughly, any type of contamination can cause this problem.

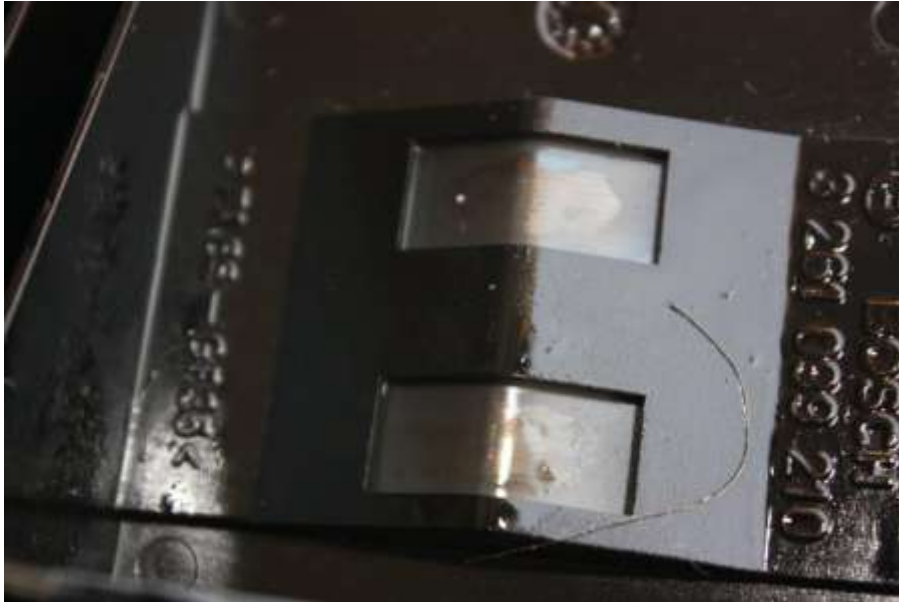
The ISS and OSS are used by the TCM and higher to calculate shifting ratios. If these sensors are impeded and give unexpected readings a gear ratio error will occur. . I also had notice a thin grey film on the valve body almost like anti-seize. Very fine metal.

Figure 11 Note Film on TCM These contacts are necessary for functioning

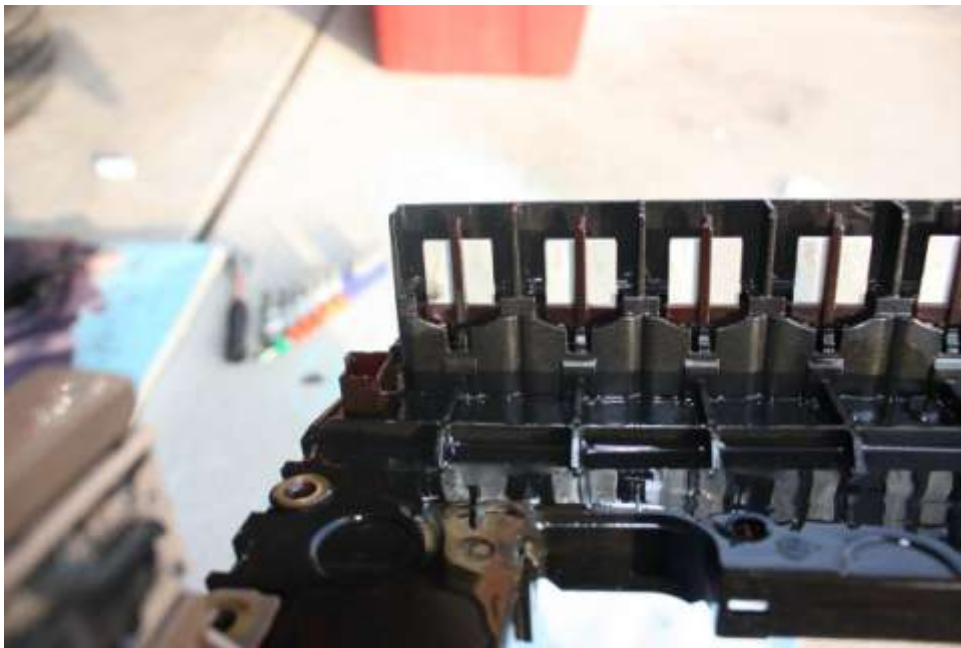
Figure 12 Clean all your contacts

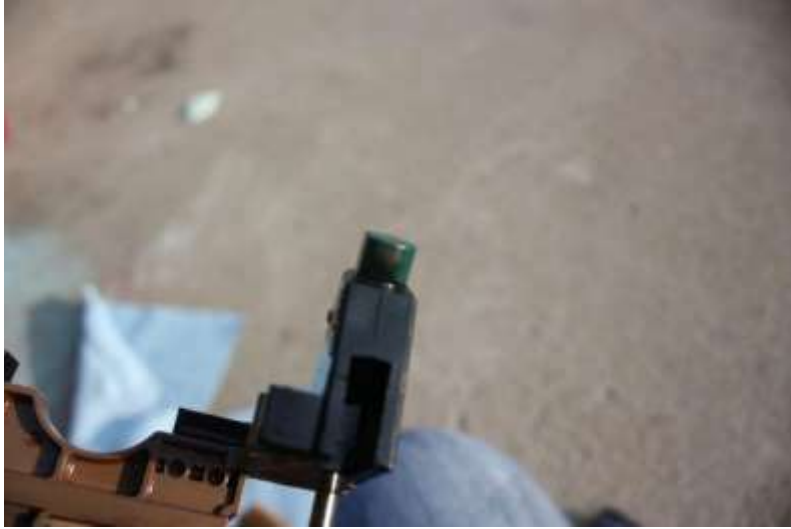
Figure 13 Take a look at this ISS Sensor. It is covered in Fine Metal which affects the readings! Clean it off

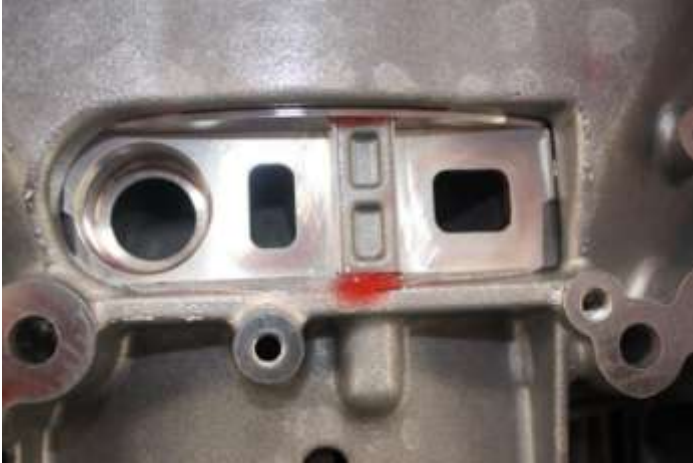
Figure 15 Bridge Seal adapter Fits Here. This seal is Prone to Cracking

12. Install the sealing Sleeves and Bridge Adapter

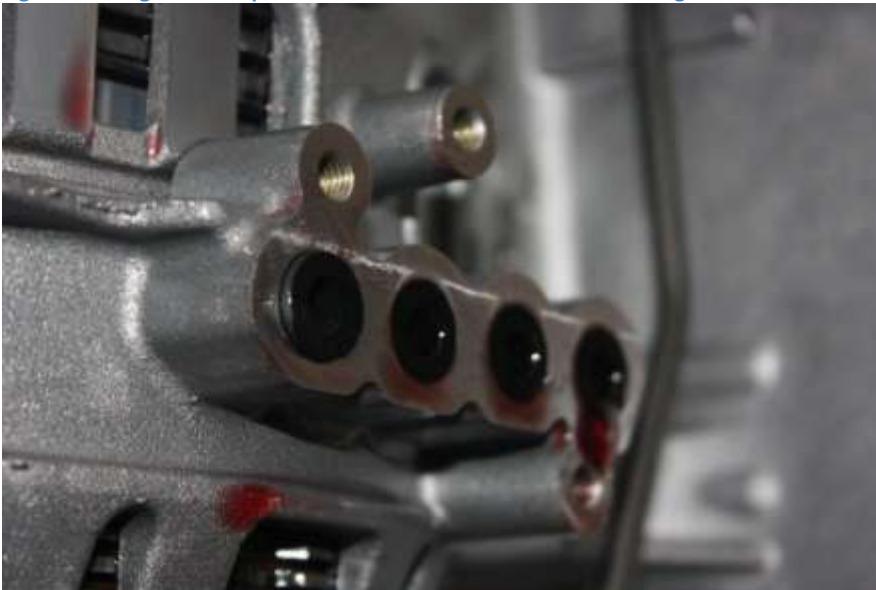
Figure 16 The 4 Sealing Sleeves Replace while its easy

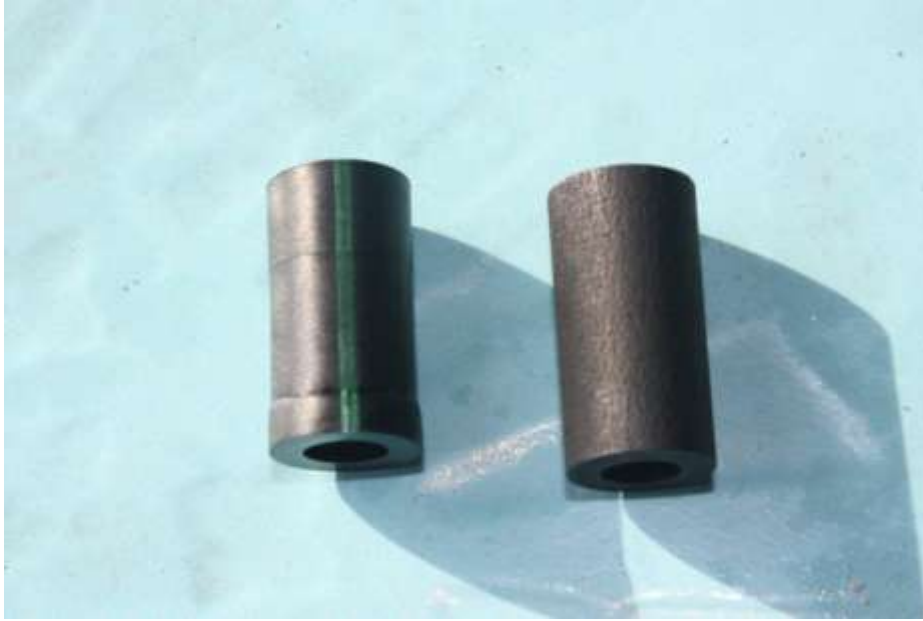
Figure 17 Old Sleeve Left New Right
