M57Y DDE Fault Code 46B7 Swirl Flap Actuator

E70 and E90 with the M57Y engine

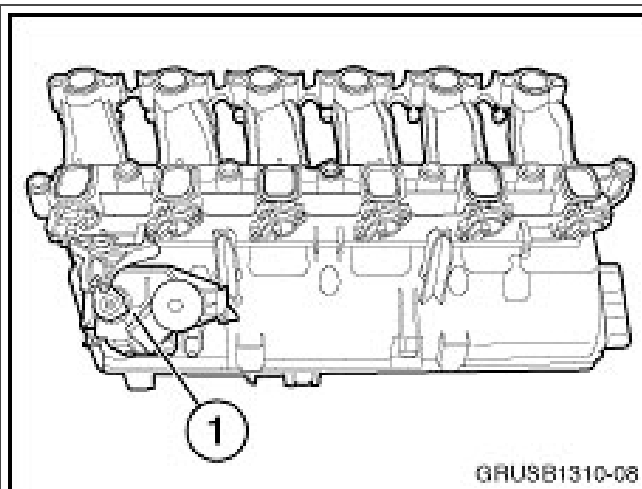
The linkage rod for the swirl flaps in the intake manifold is binding at the pivot point of the swirl flap actuator.

Remove the intake manifold (refer to Repair Instruction REP11 61 050). Turn the manifold over to access the swirl flap actuator (1).
