SI B11 02 08

Technical Service

Power Reduction, FC 2A82 Intake VANOS and/or FC 2A87 Exhaust VANOS Camshaft Faults are Stored in DME

Tech Tip: BMW's Power Reduction and Vanos Faults Are Stored In DME

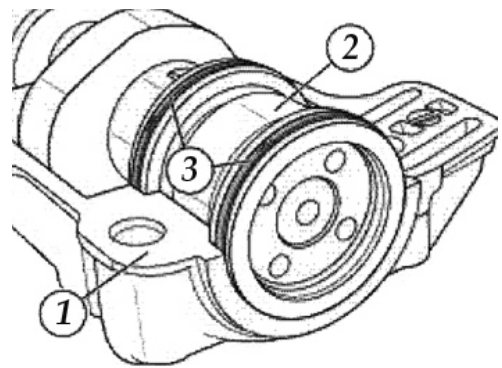
Fig. 2

If the oil filter cap is found intact, it is possible that the camshaft hook ring seals (3) have worn a groove into the camshaft bearing ledge (1), causing a drop in oil supply to the VANOS unit.

Figs. 2, 3 and 4 are illustrations of worn *Fig. 3*

camshaft bearing ledges and the acceptable wear of the camshaft bearing ledge.

If excessive wear to the camshaft bearing ledge is found, it is only necessary to replace the camshaft hook ring seals and the affected camshaft bearing ledge. N51, N52 and N52K intake camshaft bearing ledges and hook ring seals cannot be replaced separately. Cylinder head replacement requires a TeileClearing PuMA case.

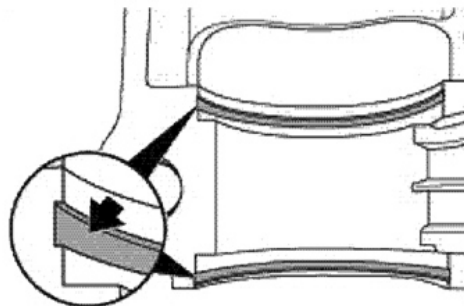
Note the deep grooves worn into the intake camshaft bearing ledge by the camshaft hook ring seals.

Note the deep grooves worn into the camshaft bearing ledge by the camshaft hook ring seals in **Fig. 3**. The camshaft bearing ledge is worn.

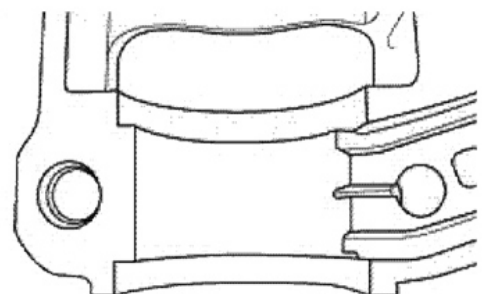
Acceptable camshaft bearing ledge – minor wear marks from the rotation of the camshaft are normal.

Fig. 4 shows acceptable camshaft bearing ledge — minor gray wear marks from the rotation of the camshaft are normal. If deep grooves are not apparent, the camshaft bearing ledge is acceptable and should not be replaced.
