Service Information Bulletin

RECALL 23V-039: SIDE AIR BAG COVER (REAR SEATS)

B52 01 23 [SI] February 2023

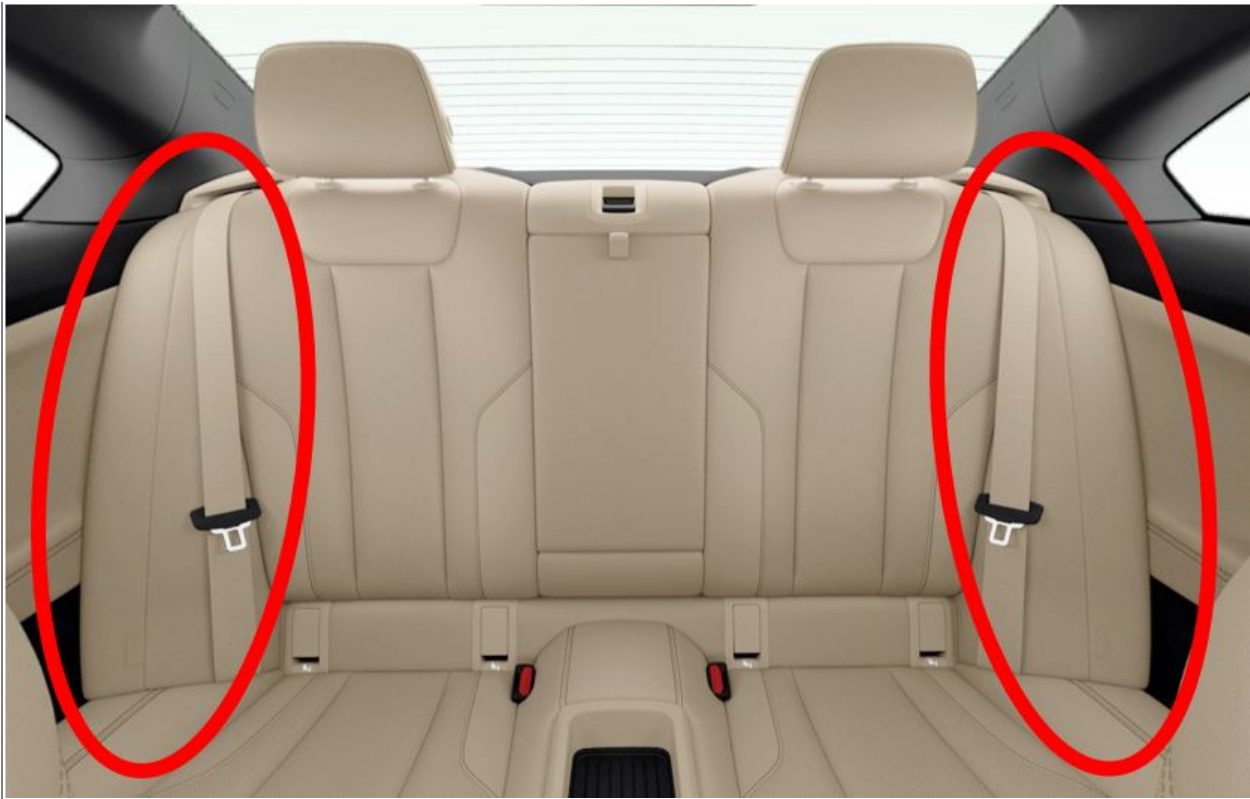
Replace the rear seat backrest side panels (left and right; circled) in accordance with repair instructions
--	---

Replace both rear seat backrest side panels which contain the air bag.

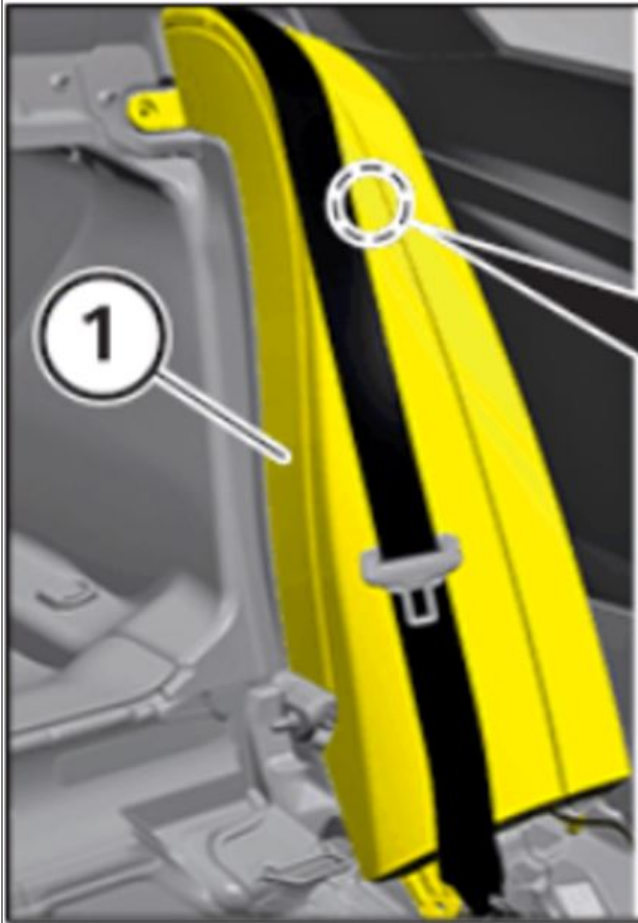
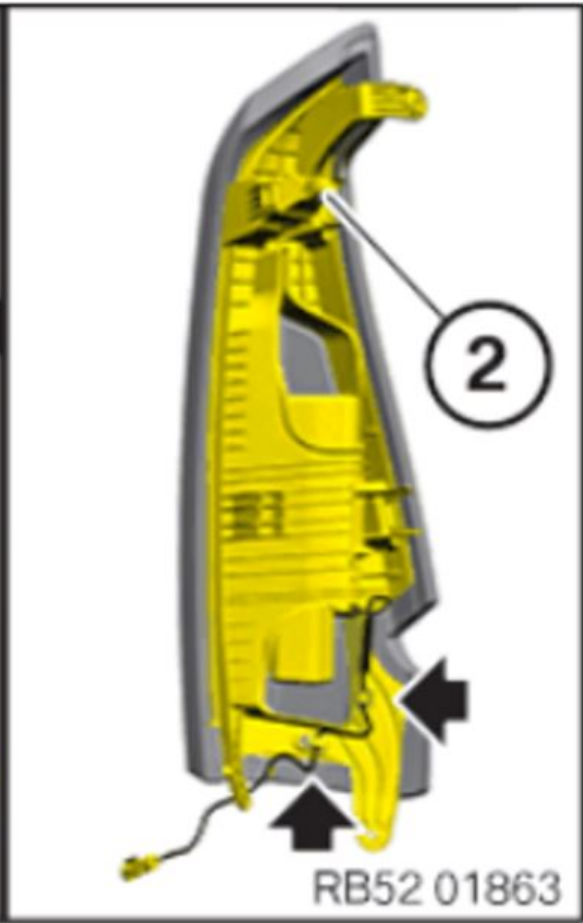
RB52 01863

Check the
clamp (2)
for damage.
A
replacement
clamp
should be
present on
the new
part.

Unclip and
remove the
backrest
side panel
section (1)
on the rear
seat
backrest
from the
clamp (2).

Repeat for
opposite
side of
vehicle.
