SI B11 02 08
Engine

November 2012
Technical Service

This Service Information bulletin supersedes SI B11 02 08 **dated June 2011**.

Power Reduction, FC 2A82 Intake VANOS and/or FC 2A87 Exhaust VANOS Camshaft Faults are Stored in DME

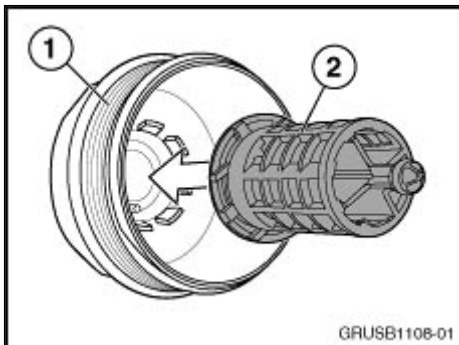
2. The oil filter cap insert may have been inadvertently removed during the vehicle's last oil service. If this insert is not installed, it will result in non-filtered engine oil being supplied to the engine, thus possibly clogging or damaging the VANOS solenoids.

If the oil filter cap insert is found to be missing, the entire oil filter housing cap must be replaced (refer to the EPC).

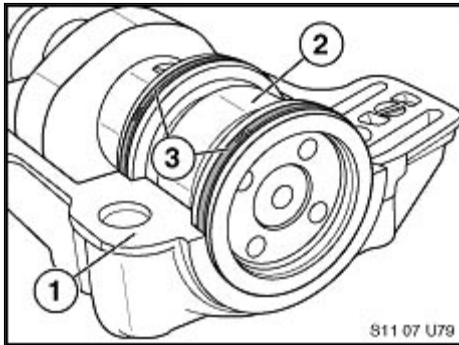
While performing the test plan for the VANOS faults stored (ABL-DIT-B1214_NGNWA or E), the inspection of the camshaft hook ring seals is advised in “**step 5 of these test plans**”.

1. Camshaft bearing ledge
2. Intake camshaft
3. Hook ring seals

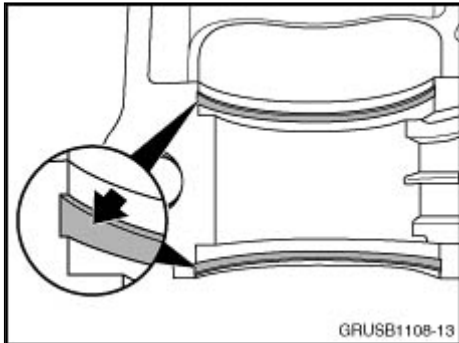
NEW Note the deep grooves worn into the camshaft bearing ledge by the camshaft hook ring seals. The camshaft bearing ledge is worn.

NEW See the magnification call-out in the illustration for a detailed description of the wear.

IMPORTANT: The applicable test plans for the faults stated in this bulletin may advise replacement of the entire intake or exhaust camshaft. This statement is an error, and will be corrected with ISTA/D 2.34.0. Do not replace the entire intake or exhaust camshaft; if applicable, only replace the bearing ledge and rectangular hook rings on the affected camshaft for the VANOS fault stored in DME Memory.

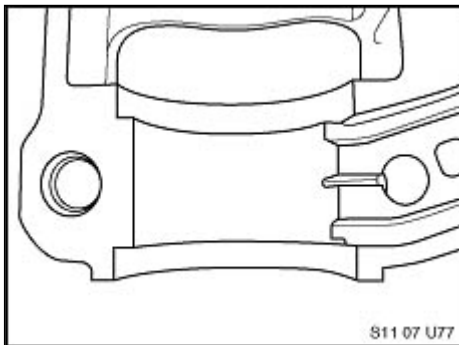
NEW Acceptable camshaft bearing ledge – minor gray wear marks from the rotation of the camshaft are normal. If deep grooves are not apparent, the camshaft bearing ledge is acceptable and should not be replaced.

NEW Do not replace parts that are not worn.
