RECALL 17V-676: BLOWER MOTOR WIRING

RE: Recall 17V-676: Blower Motor Wiring B64 07 17

**Safety Recall 17V-676
Blower-Motor-Wiring
Model Year 2006-2011
BMW 3 Series (including M3)
Last Update: 10/30/2017**

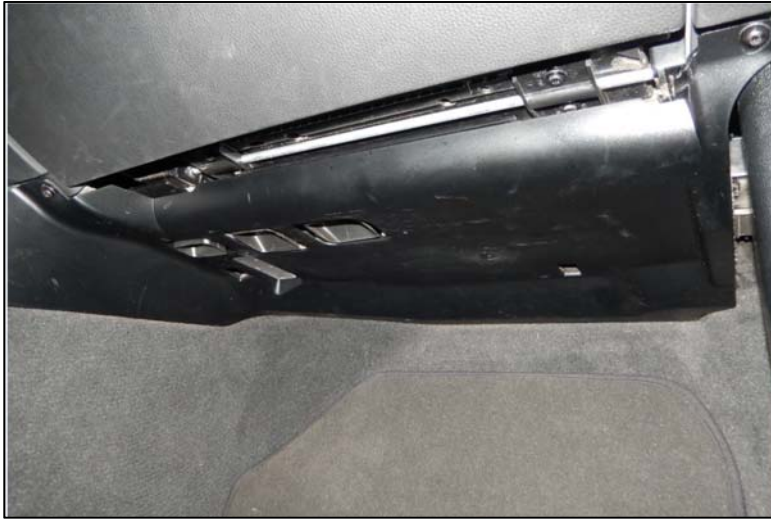
Disconnect the battery before performing this repair per repair instructions "61 20 900 Disconnecting and connecting battery ground lead".

Remove the passenger front lower dash trim and glove box per repair instructions "51 16 360 Removing and installing right glove box" or "51 16 366 Removing and installing right glove box (with airbag) with housing" or "51 16 366 Removing and installing right glovebox with housing".

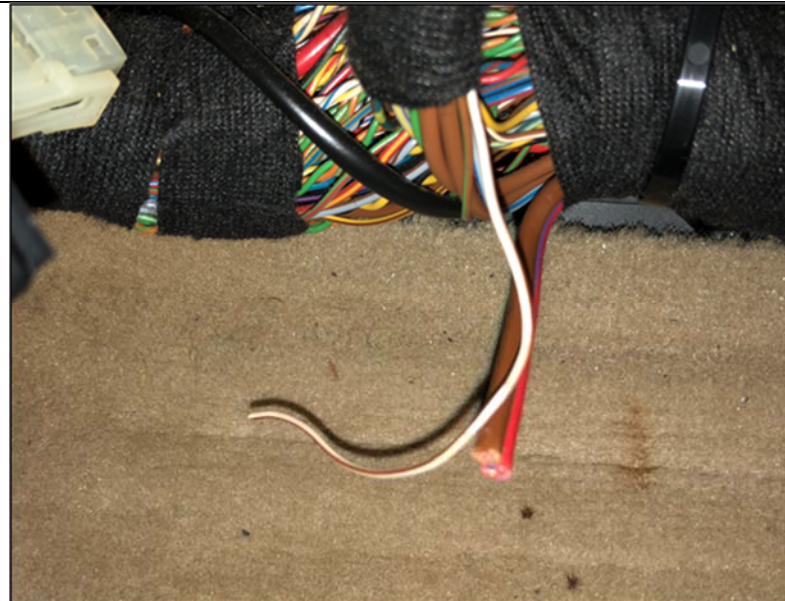
Cut the wiring on the vehicle side for the Red/Violet and Brown wire as close to the main harness as possible (These 2 wires will no longer be used).

Cut the White/Brown wire leaving about 4-5 inches of wire coming out of the main harness (this will be used and spliced into the repair harness).

Replace the blower regulator by removing the 2 screws (2).

Prepare for shipping (all parts will be collected).

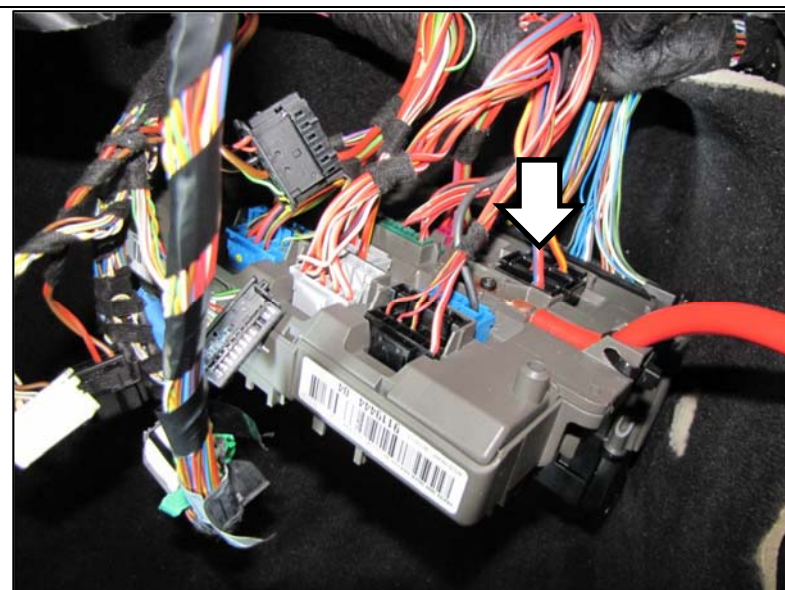
Remove 6 pin connector indicated by white arrow from the back of the Power Distribution Box by releasing the 2 tabs (red arrows) with a small screw driver or pick.

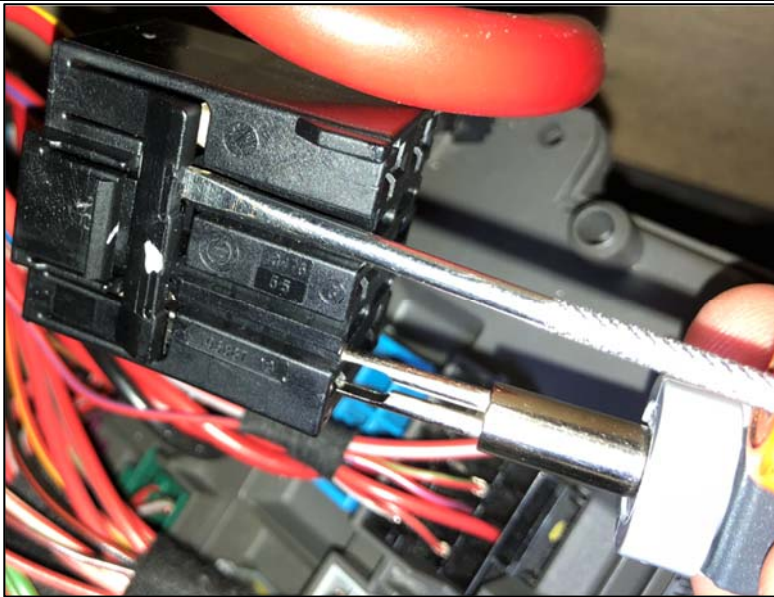
Remove the **Red/Violet** wire from the connector using special tool 61 0 317 from kit (610 300 – P/N 83 30 0 495 382) and a small screwdriver. Refer to SI B04 03 06.

Up to 3/2007 X11007 Pin 6 (F67)
From 3/2007 X11011 Pin 2 (F88)

Once the wire is removed it can be pulled from the harness and discarded.

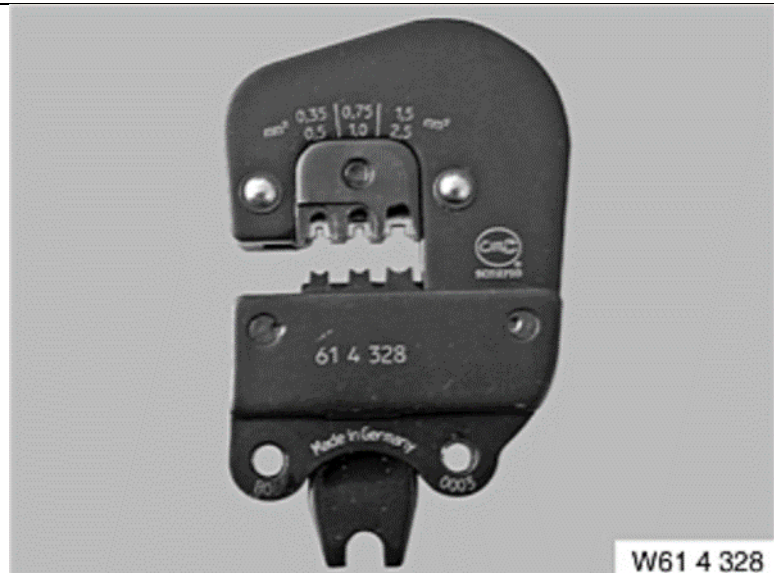
W61 4 328

Prior to installing the repair harness into the vehicle, strip the end of the White/Brown wire, push over the heat shrink tube and crimp one end of the supplied butt connector to the repair harness using crimping tool 614 328 (83 30 0 496 833) Refer to B04 32 06.

This step makes it easier to crimp outside the vehicle prior to installing the repair harness.

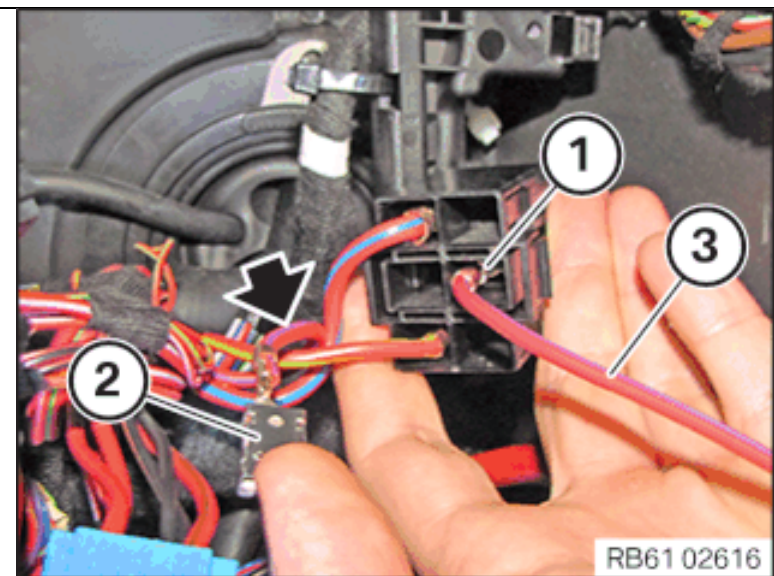
RB61 02616

Insert the new wire (1) (3) **Red/Blue** from the repair harness into the location where the original wire was removed.

Please note the difference in wire color. There is an existing Red/Blue wire already in the connector that should not be touched

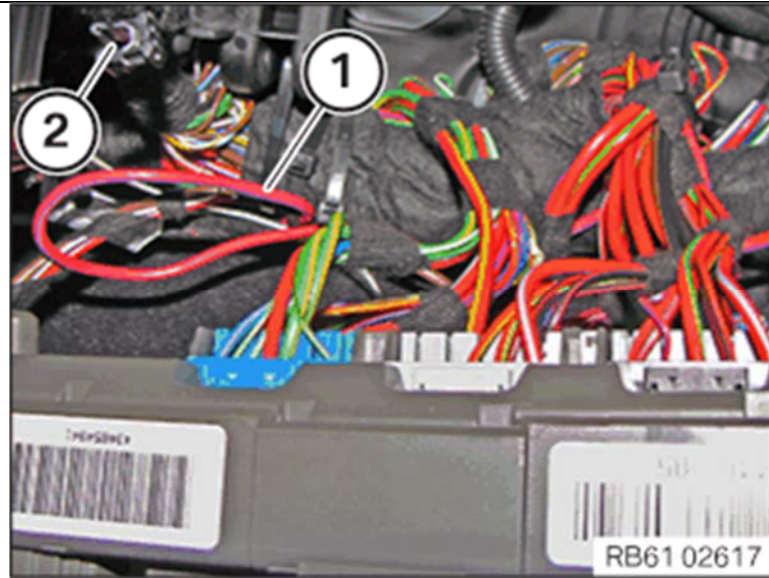
Note: be careful of the sharp edge clip (2) when routing the new harness (1) along the existing vehicle harness.

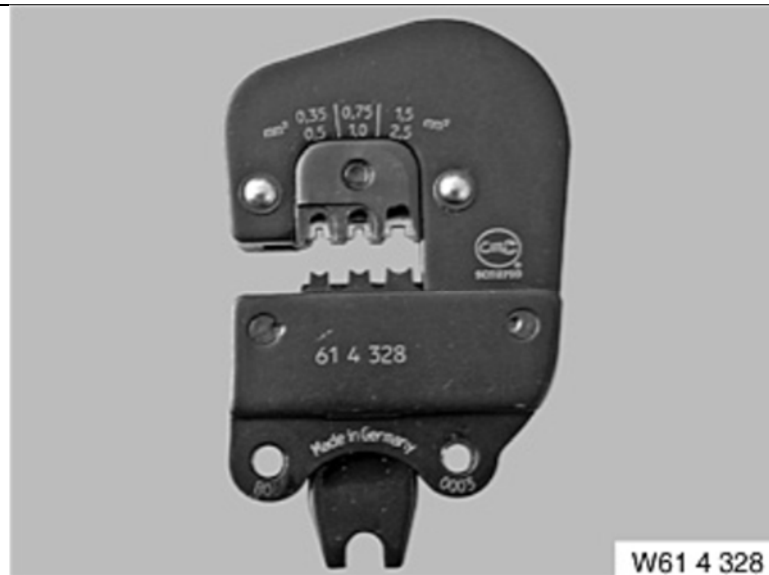
Strip the other end of the vehicle harness White/Brown wire, and crimp to the new wire from the repair harness using crimping tool 614 328 (83 30 0 496 833) Refer to B04 32 06.

Slide the shrink tube and use a heat gun to seal the shrink tube.

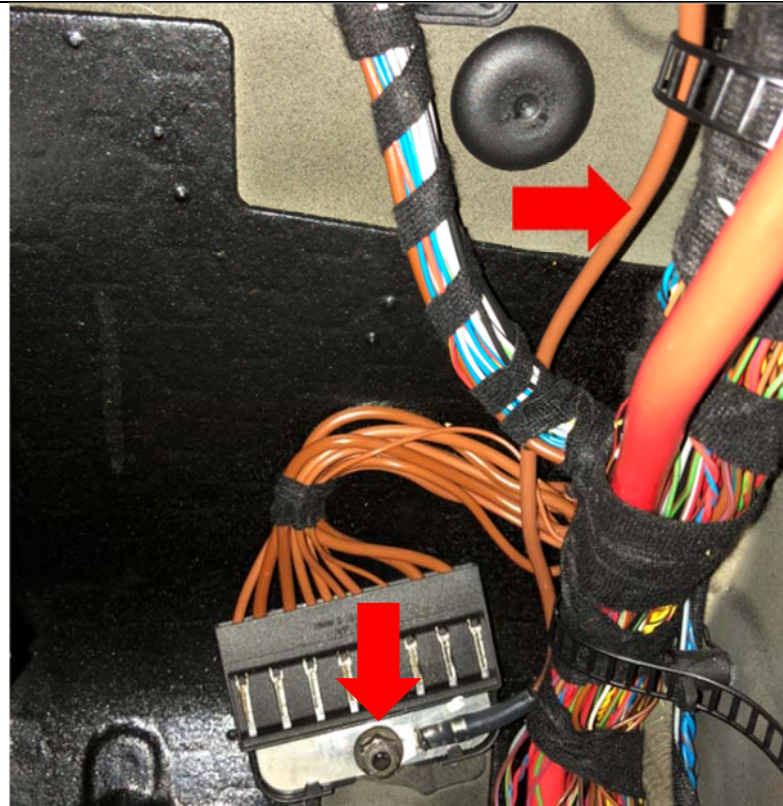
Remove the lower passenger side A-pillar trim.

Carefully lift the carpet from the passenger side footwell area.

Route the Brown wire from the repair harness down to the ground point location.

Remove the nut from the ground point and install the wire end onto the stud and torque to 8Nm using a torque wrench.

Reinstall the carpet and A-pillar trim.

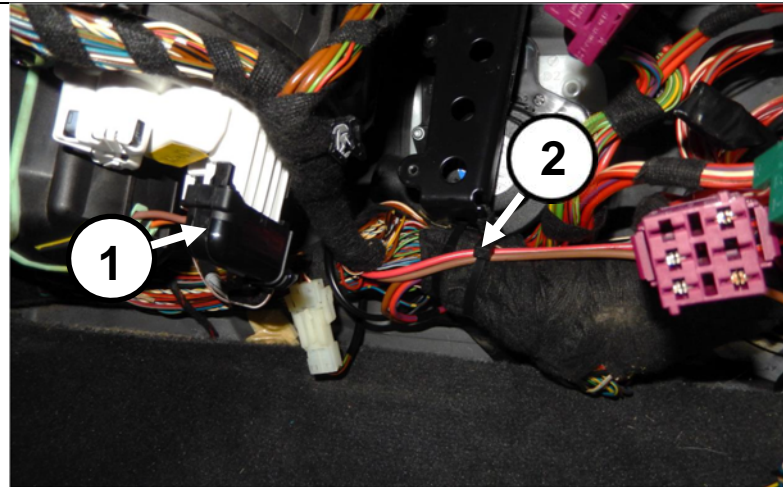
Connect the new repair wire harness connector to the blower regulator (1)
Secure the repair cable in place (2) using cable ties along the existing vehicle harness.

Reinstall the Power Distribution Box and Junction Box Electronics module.

Reinstall the glove box and lower trim.

Connect battery as per repair instructions "61 20 900 Disconnecting and connecting battery ground lead". Torque battery terminal to 5Nm.

Test the operation of the blower.
