Service Action: Replace Charge Air Temperature Sensor (M57Y)

E70 with the M57Y diesel engine produced from 1/22/2008 to 4/31/2011

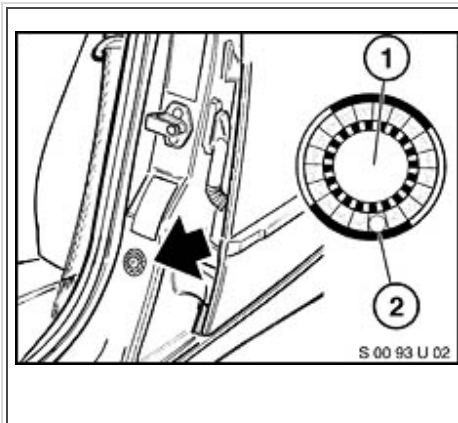
This Service Action has been assigned code number **600**. After the vehicle has been checked and/or corrected, obtain a label (SD 92-395) and:

- A. Emboss your BMW center warranty number in the middle of the label (1);
- B. Punch out code number **600** (2), printed on the label; and
- C. Affix the label to the B-pillar as shown.

If the vehicle already has a label from a previous Service Action/Recall Campaign, affix the new label next to the old one. Do not affix one label on top of another one, because a number from an underlying label could appear in the punched-out hole of the new label.
