DIY Pulling and troubleshooting the ZF 6HP26 Mechatronics Unit E-shift Unit

pulled from various sources by Wilson009

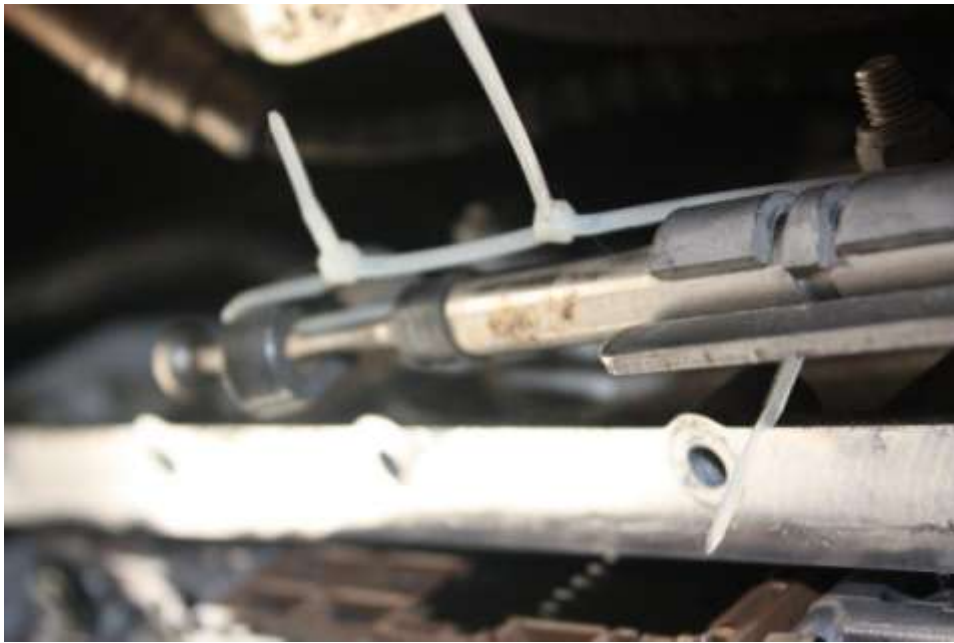
3. Dispose of you old transmission pan but before you do tear it apart to inspect the filter to see how much metal is in it. Also inspect your magnets. Mine and Keifers were fairly coated which I think is normal after 120K.
4. Tie back the Brake Cable

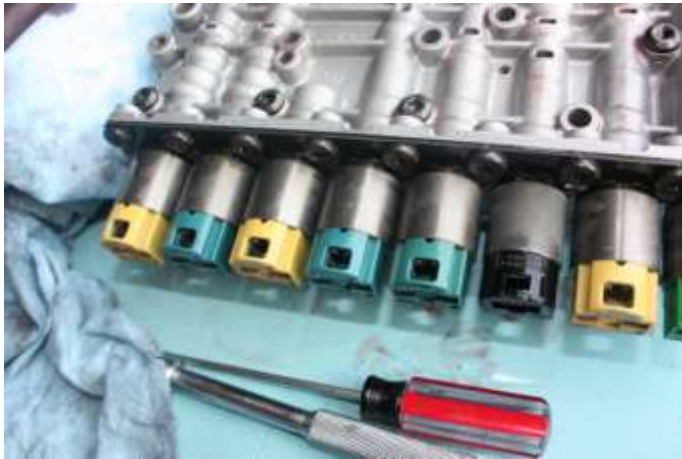
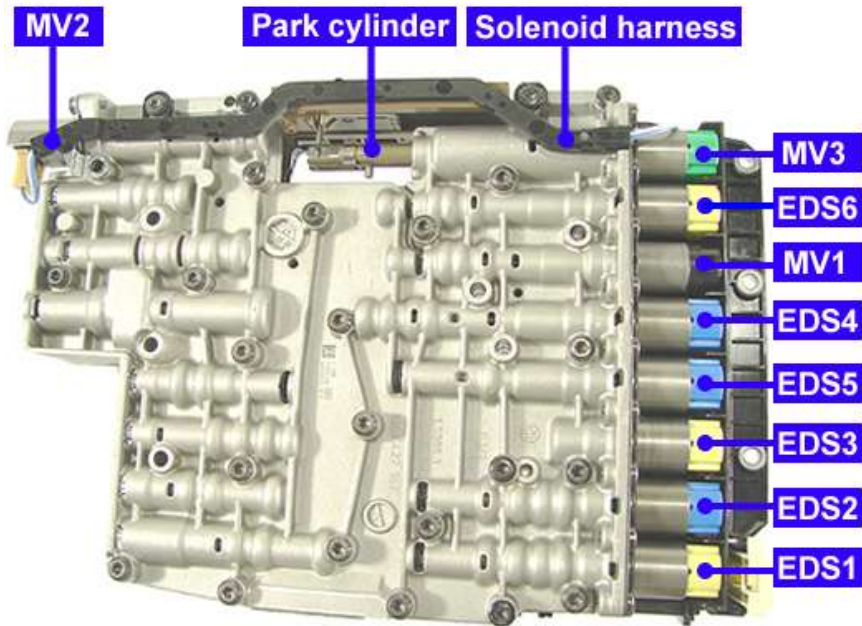
6. Now that the mechatronics is out you need to Ohm Test each Solenoid. EDS 1-6 (blue and Yellow caps) Solenoids have a resistance of around 5 ohms while MVS 1-2 (black caps) solenoids resistance is 12 ohms. MVS 3 (green cap) solenoid resistance is 25 ohms.

7. This is where I found my parking lock error. MV2 which is responsible for that and an open circuit or a reading of 1. I ordered a replacement from ZF distributor Errickson Industries for \$60 bucks. Excellent company very friendly. Contact is Nat www.erikssonindustries.com 800-388-4418 in CT. Had my package in 2 days. This fixed my Parking Lock errors.
