REP-REP-RAE9051-5171371 Removing and installing/replacing trailing link on left or right spring strut dome
VIN: XXXXXXXX

Removing and installing/replacing trailing link on left or right spring strut dome

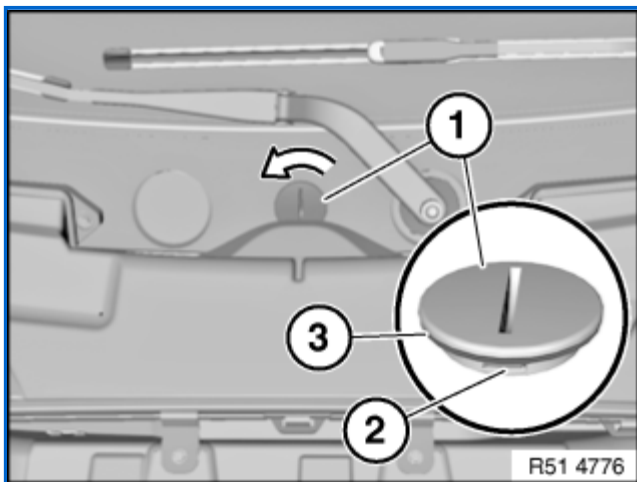
Important!

Risk of damage!

Latch mechanism (2) and gasket (3) of the cover (1) must not be damaged.

Even minor damage to the cover (1) can lead to water ingress; replace cover (1) if necessary.

Note:

Cover (1) available in two versions:

- Turn cover (with notch) about 45° to the left

- B. Disengage cover (without notch) in upward direction

Remove cover (1) and release screw underneath.

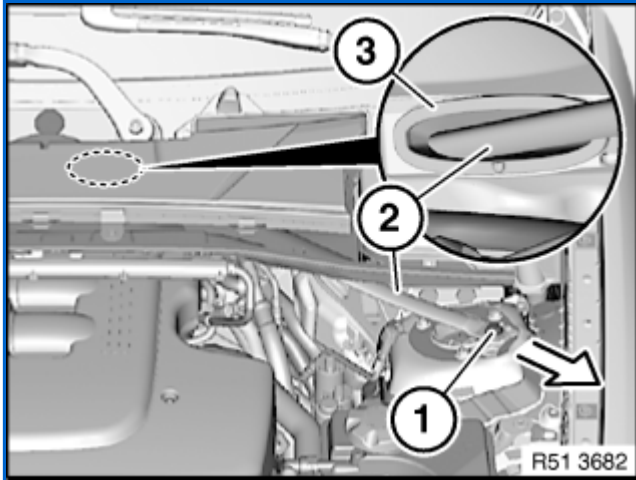
Version A:

Note:

Grommet (3) must not be pulled out of the bulkhead, as correct feeding in is not possible in installed state.

Release screw (1).

Hold down grommet (3) and pull out tension strut (2) in direction of arrow.

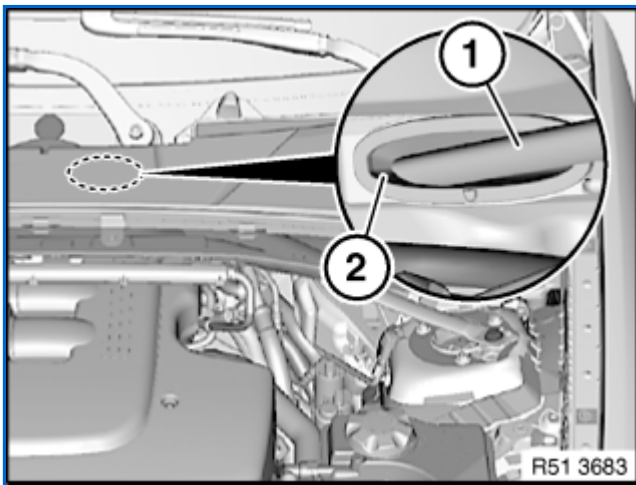
Installation note:

Replace screws.

Feed tension strut (1) carefully into the grommet (2).

Tighten screws to torque and then tighten to angle of rotation using special tool [00 9 120](#).

Tightening torque [51 71 2AZ](#).

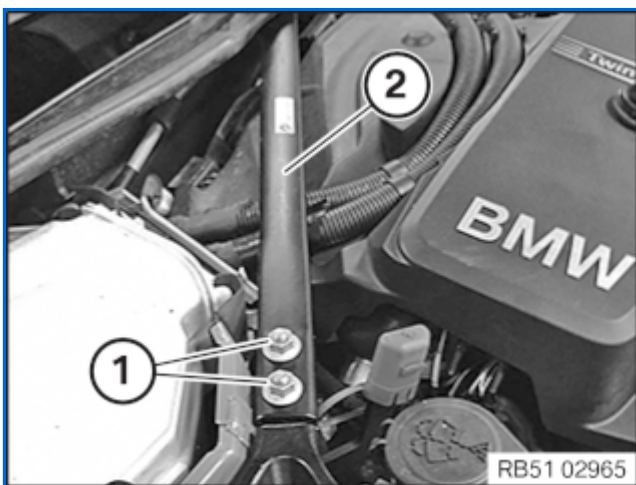
Version B:

Loosen the nuts (1) and remove the strut brace (2).

Tightening torque [51 71 19AZ](#).

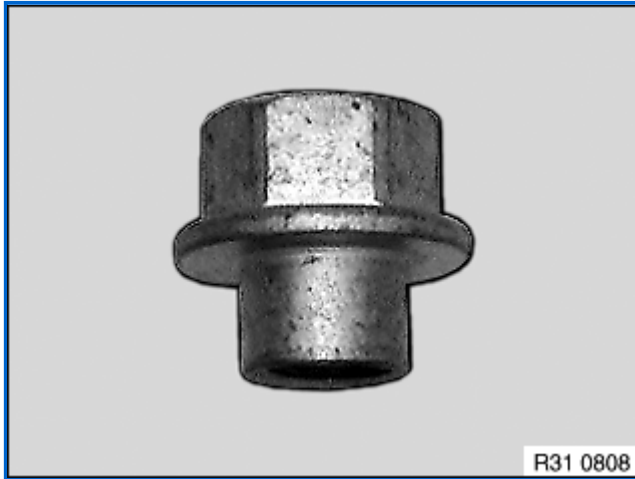
Important!

The nuts shown must be used to ensure the screw connection of the strut brace ring is correct.

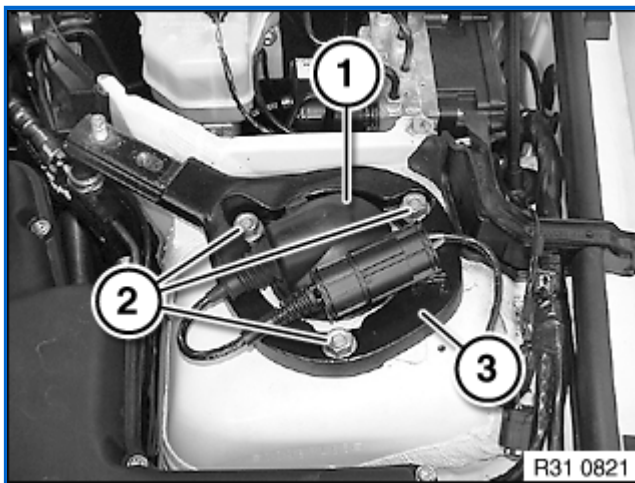
Unclip protective cap (1) and disconnect plug connection underneath.

Slacken nuts (2) and remove the strut brace ring (3).

Replace nuts (2).
